EVALUATION OF 1978 REHABILITATION SITES AND EROSION CONTROL TECHNIQUES

REDWOOD NATIONAL PARK WATERSHED REHABILITATION

TECHNICAL REPORT
APRIL 1980

MARY ANN MADEJ,
HARVEY KELSEY, AND
WILLIAM WEAVER

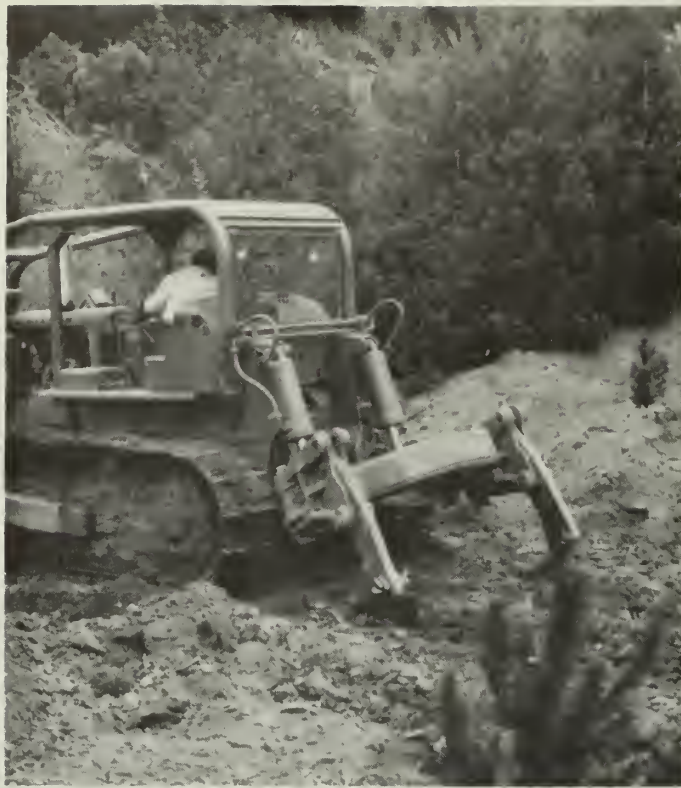
Figure 4: Most logging roads are surfaced with eight to twelve inches of rock and must be disaggregated to promote infiltration and revegetation. Here, a D-8 Cat decompacts the C-10 road with its ripper teeth.

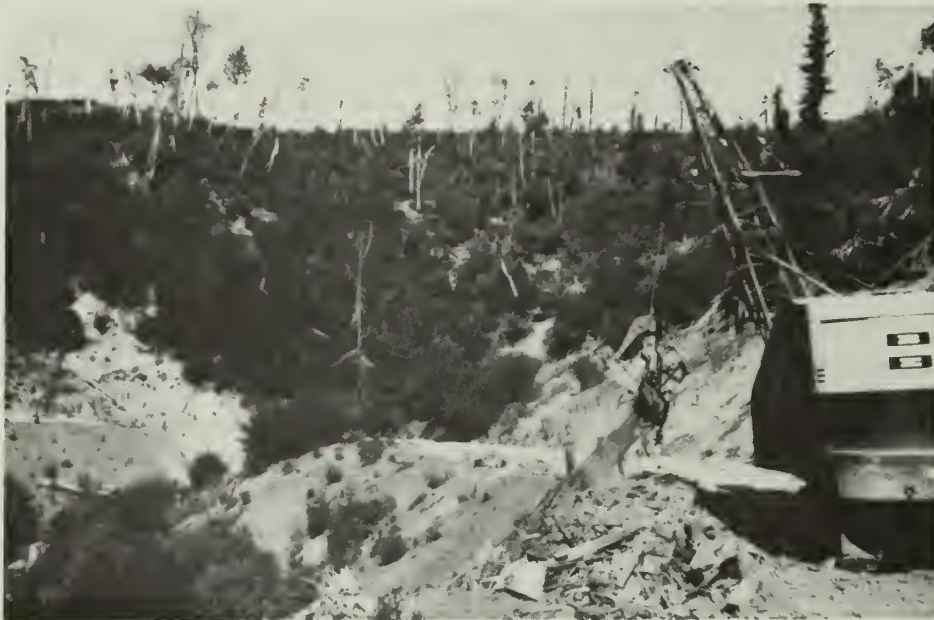
Figure 5: Because of its long reach, a dragline crane is used to lift unstable side cast road material and organic debris to the road bench.

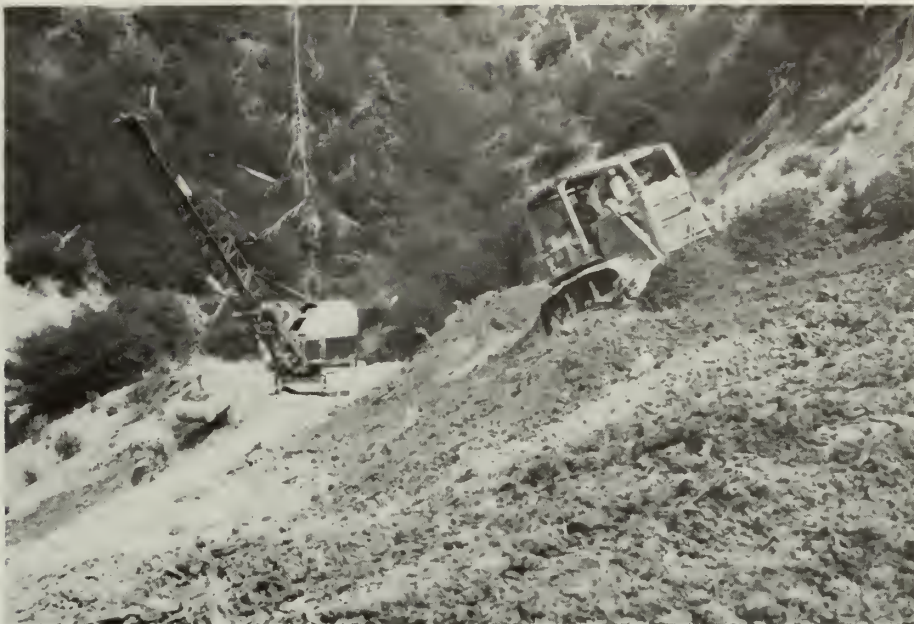
Figure 6: Excavated fill is piled along the inboard edge of the road and against the road cut bank. A tractor grades the fill to achieve a gentle outslope on the former road alignment.

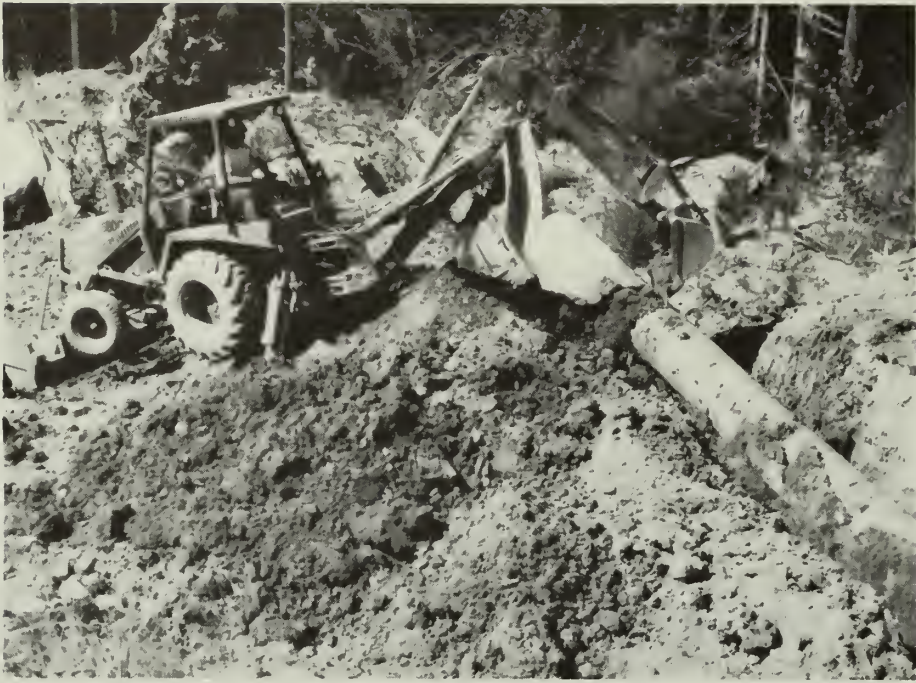
Figure 19: A backhoe excavated and removed culverts from the C-90 road, and smoothed out the resulting trough to form a cross road drain with gently sloping banks.

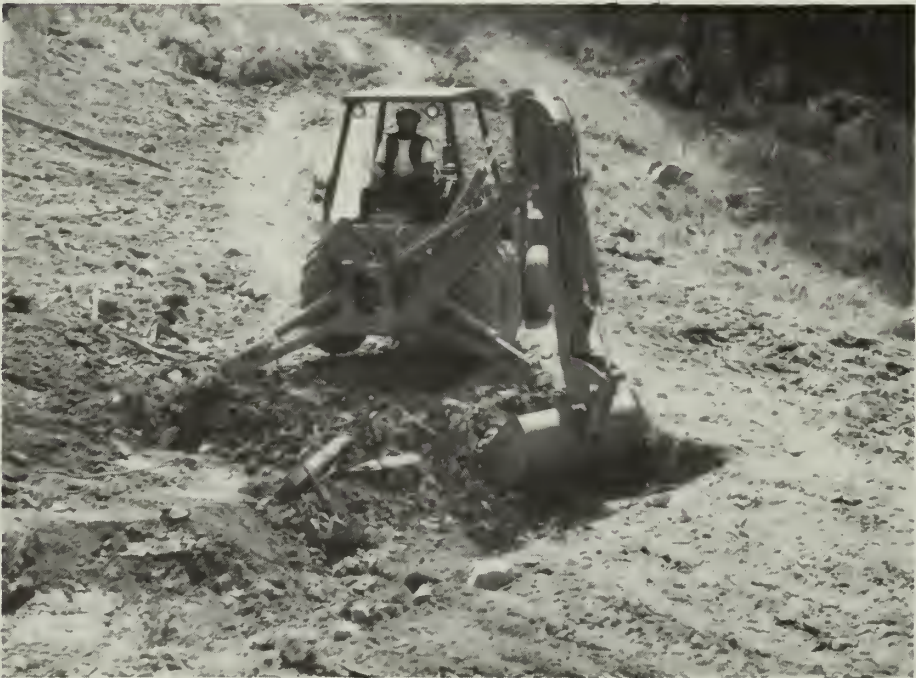
Figure 20: To prevent runoff from concentrating in the inboard ditch, cross road drains are excavated along the C-90 road by a backhoe.

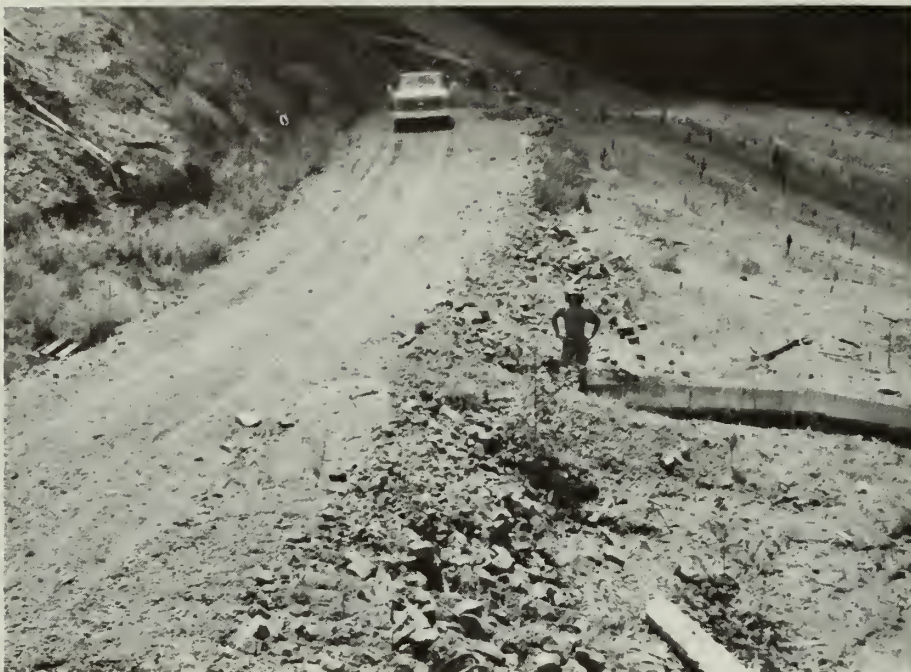
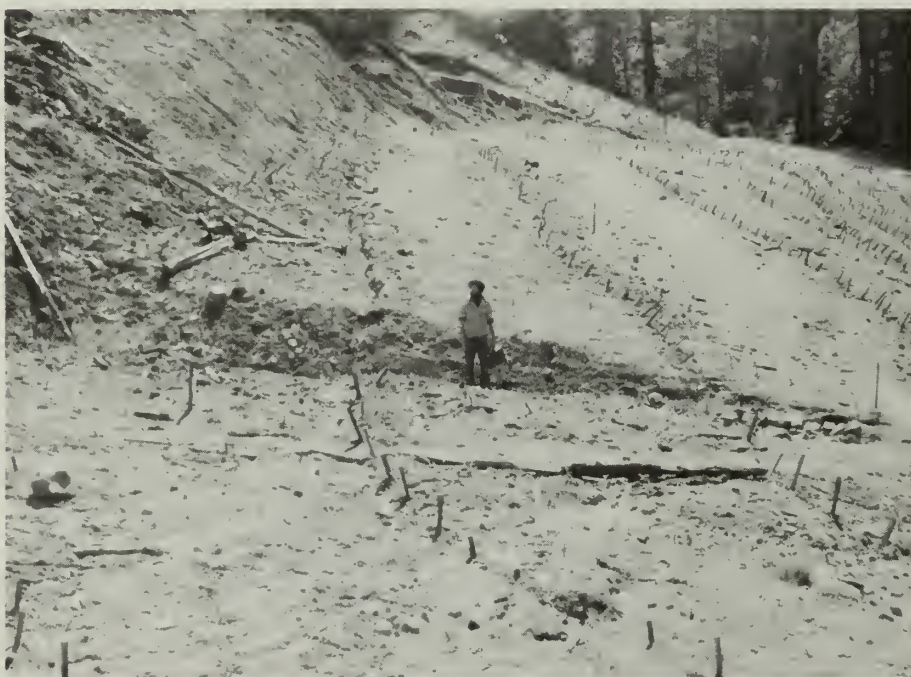
Figure 24: PP24 3/19/79

Figure 23: PP24 8/23/78
Before and after sequence of culvert removal
and road outsloping. A backhoe excavated a
cross road drain in the former culvert location.

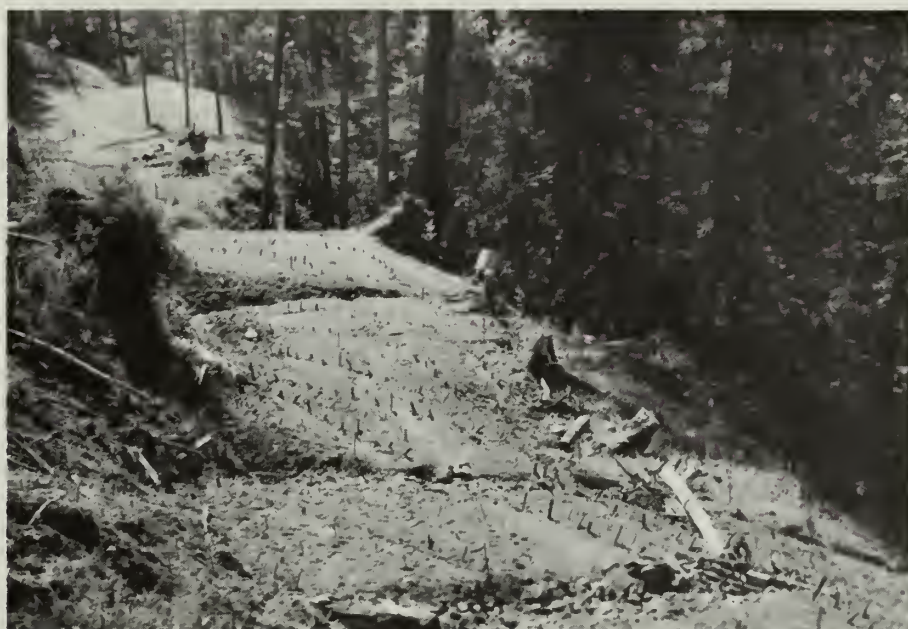
Figure 26: PP16c 3/19/79
After rehabilitation, C-90 road has been decompacted and outsloped, and the inboard ditch has been filled in. Surface runoff now crosses the removed road through cross road drains rather than concentrating and flowing along road alignment.

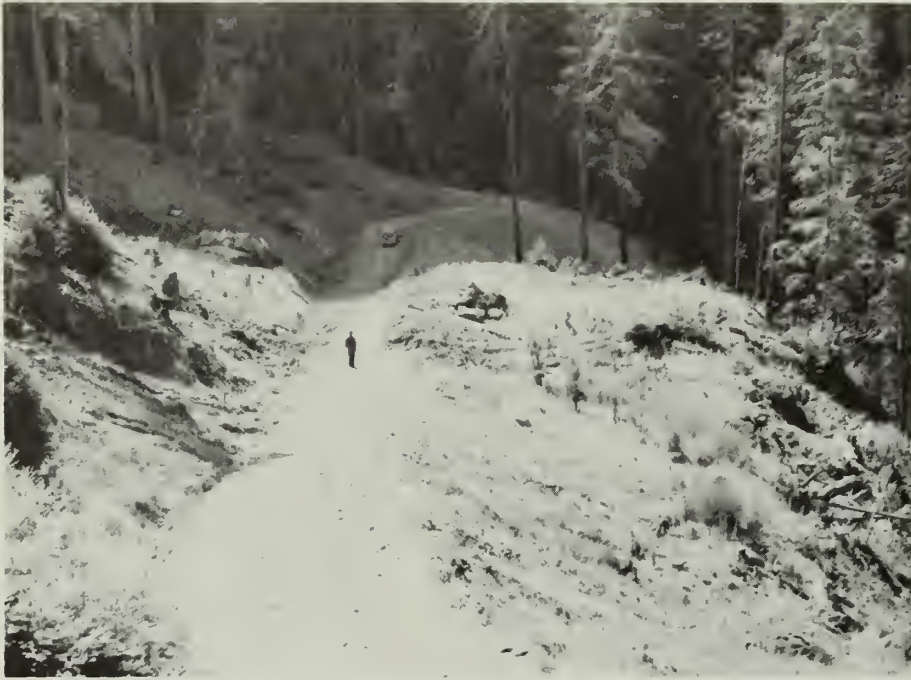
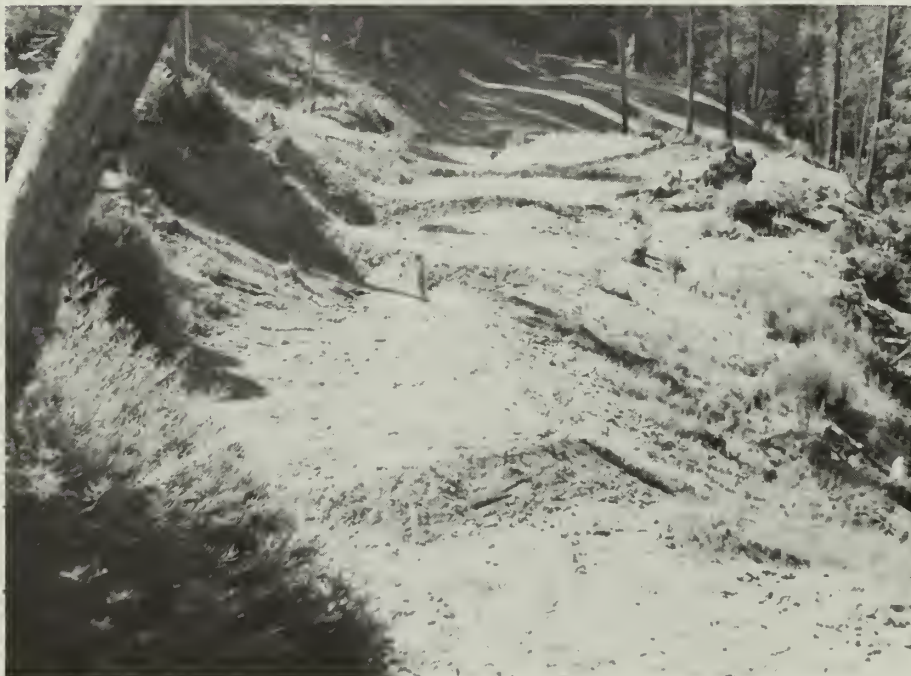
Figure 28: PP19b 3/19/79

Figure 27: PP19b 8/23/78
Before and after sequence showing removal of road and construction of cross road drains on a portion of the C-90 road.

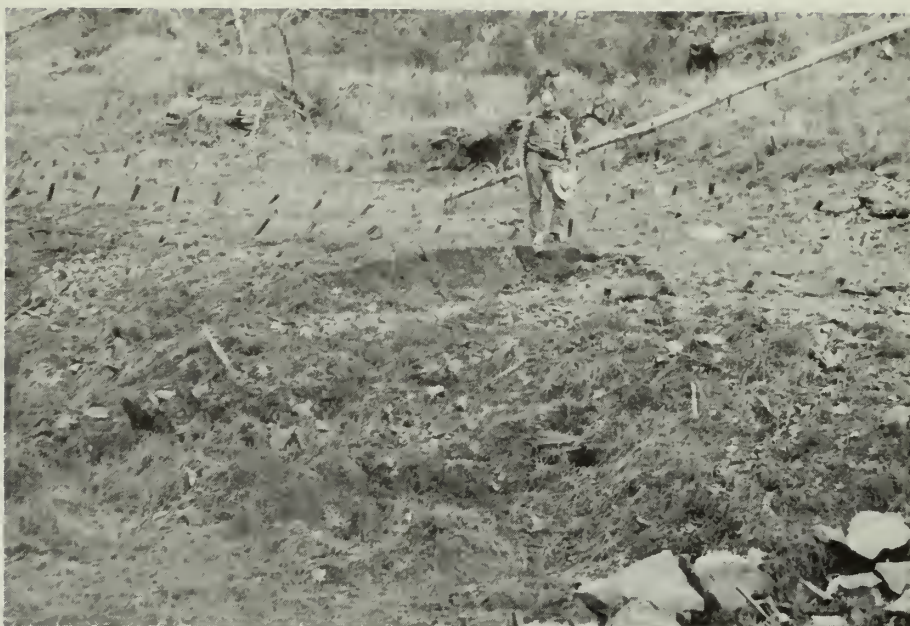
Figure 31: April, 1979.
A small slump occurred on a recently wattled slope in an area with few cross road drains.

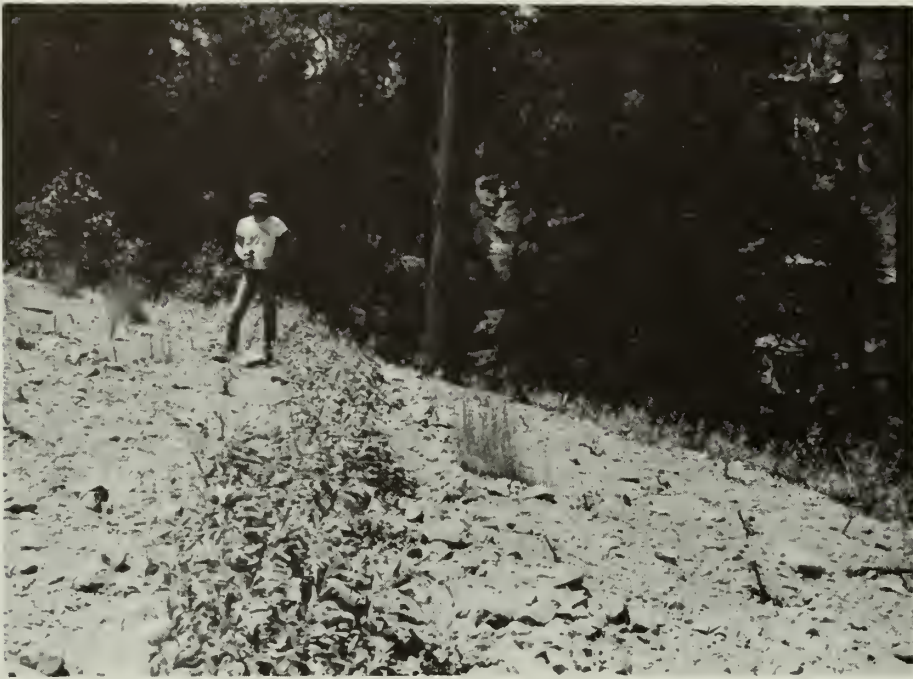
Figure 33: Willow wattles have sprouted vigorously on moist slopes on the Emerald Creek Rehabilitation Unit. Willows were planted 7 months before this photo was taken. Grass cover is sparse (1-2%).

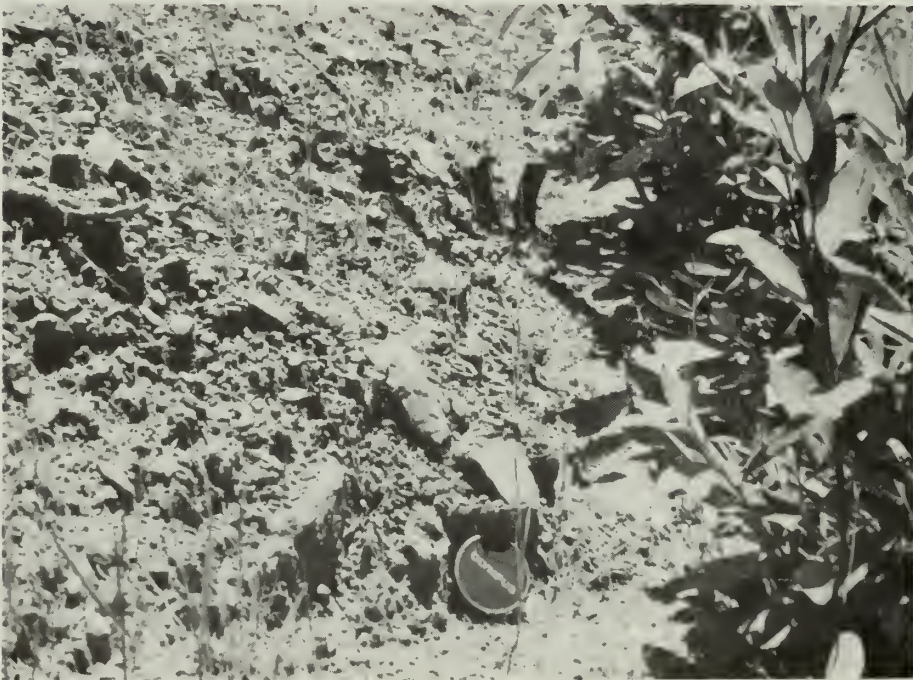
Willow wattles were built on most pulled road surfaces and on outsloped fill materials. Wattle terraces trapped sediment ranging from silts and clays to material 12 millimeters in

diameter (Figure 34). Few rills developed on wattled slopes, whereas they are more prevalent on similar slopes that are bare and unwattled.

Figure 34: Terraces upslope of willow wattles trap fine grained soil particles which are carried downslope by runoff. The wattles impede downslope soil movement and surface rilling by providing a physical barrier to runoff.

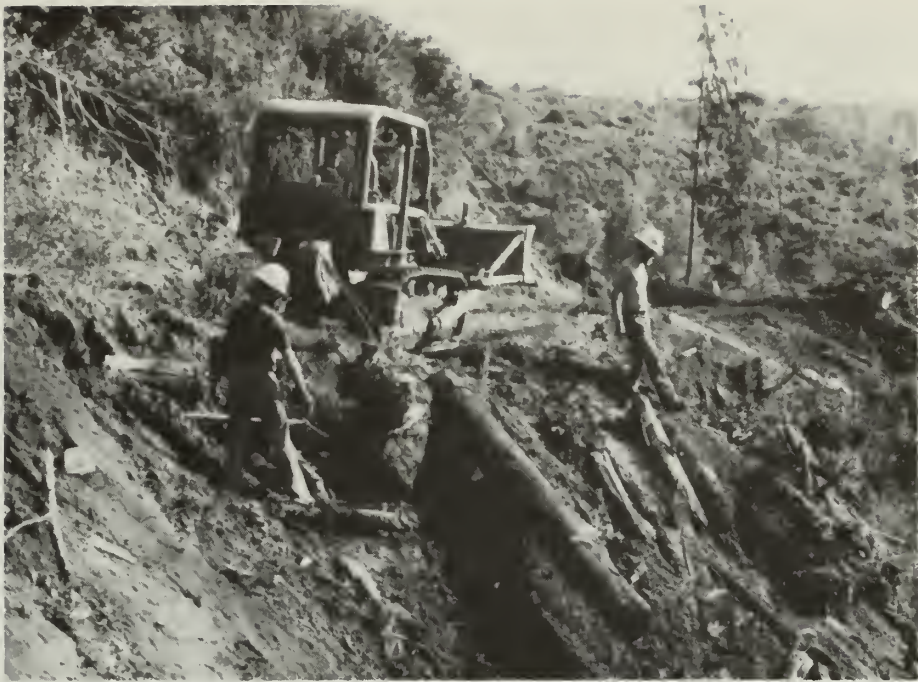
Figure 37: Organic debris that was incorporated in road fill is winched out of stream crossings by a caterpillar tractor.

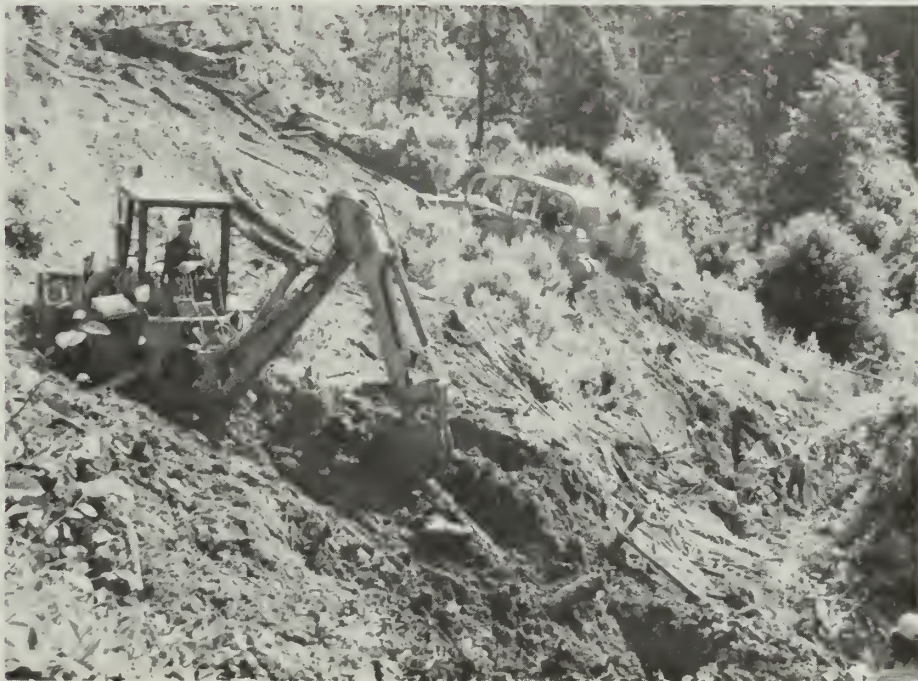
Figure 38: A small backhoe is used to excavate road fill and organic debris from stream crossings. Stream banks are recontoured to achieve stable slopes. The cat in the background of the picture is winching large debris from the channel before the backhoe does the 'finish-up' work in clearing the channel.

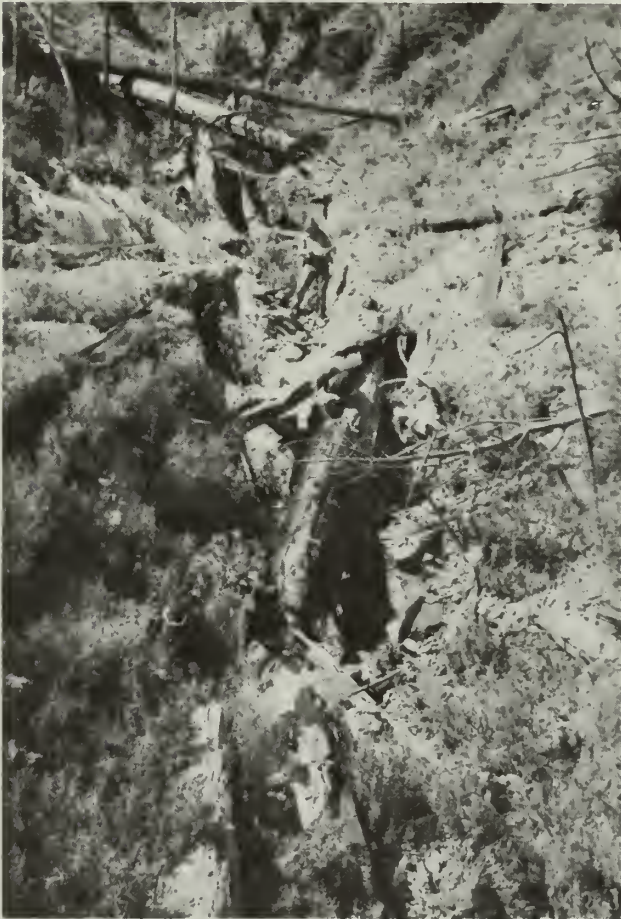
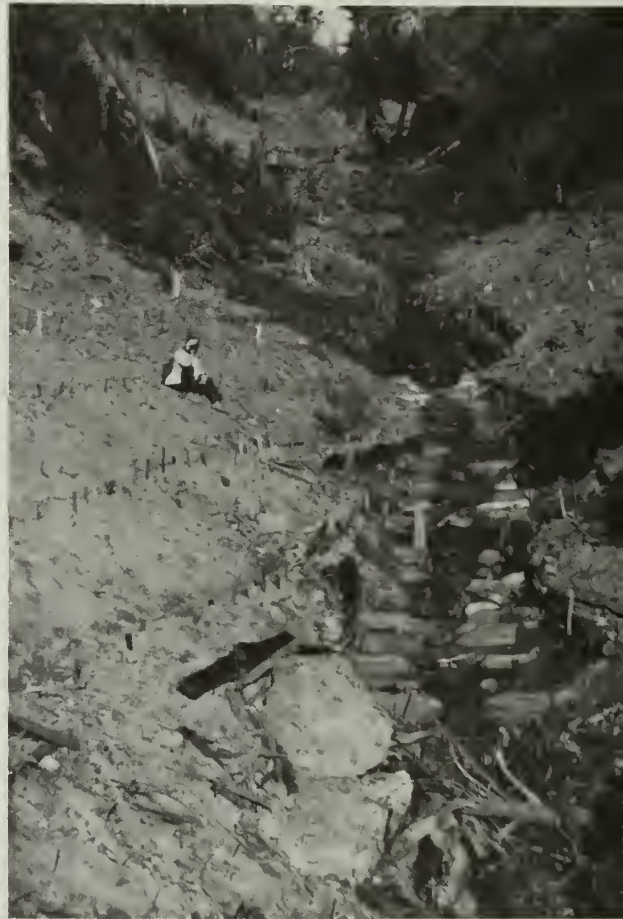
Figure 39: PPD6 9/7/78

Figures 39-44: The following 3 pairs of photographs are before and after sequences that show perennial stream channels filled with organic debris and fill material from skid roads prior to treatment. The second photo of each pair shows the same channel reach after debris is cleared and excavated and the slopes are recontoured. A small backhoe was used to clear channels, and a tractor aided in winching debris from channels.

Figure 40: 1/4/79
Stream crossing 7-K. Note series of check dams in channel and willow wattles on slope. (Note: this photo will be reshoot to get the same perspective as 39).

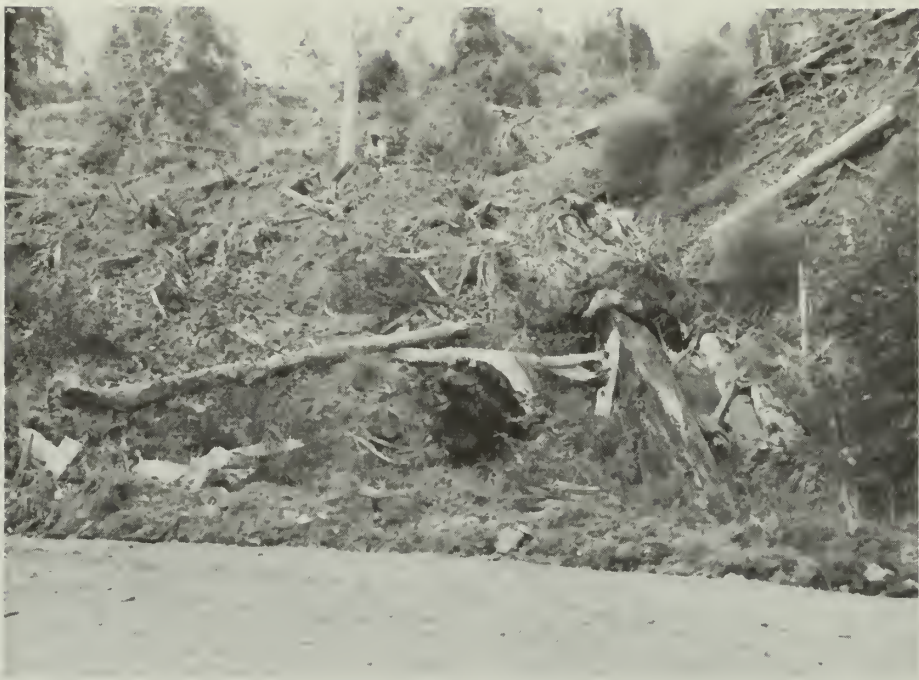
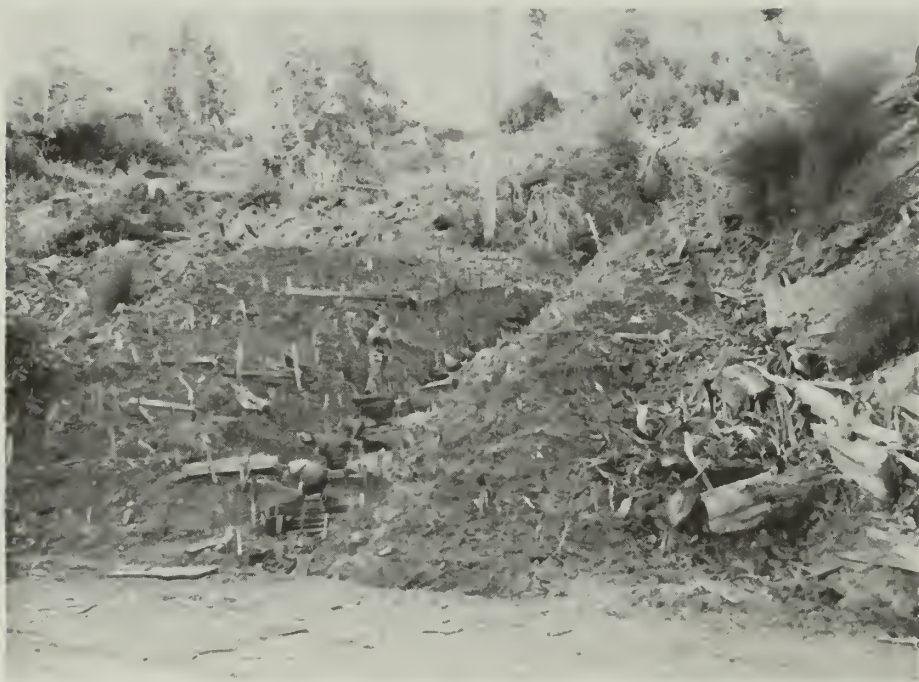
Figure 43: PPE17 9/7/78

Figure 44: 1/4/79
Note check dams in channel, willow wattles on slope, and staggered planter boxes staked into slope.

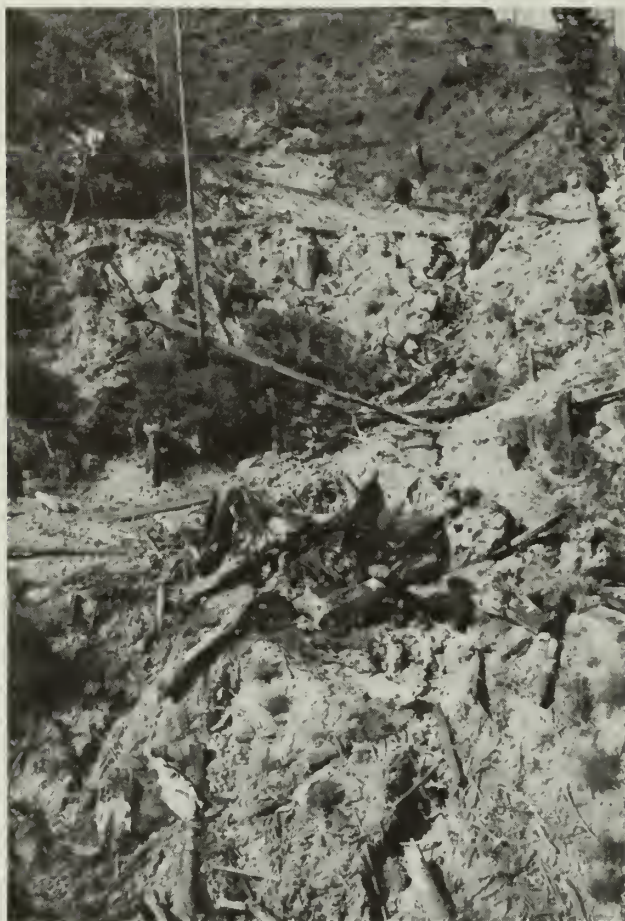
Figure 47: PPA1 9/7/78
Before rehabilitation, this site shows two parallel skid roads, the unstable fill slopes, and a gully running down the length of the photo.

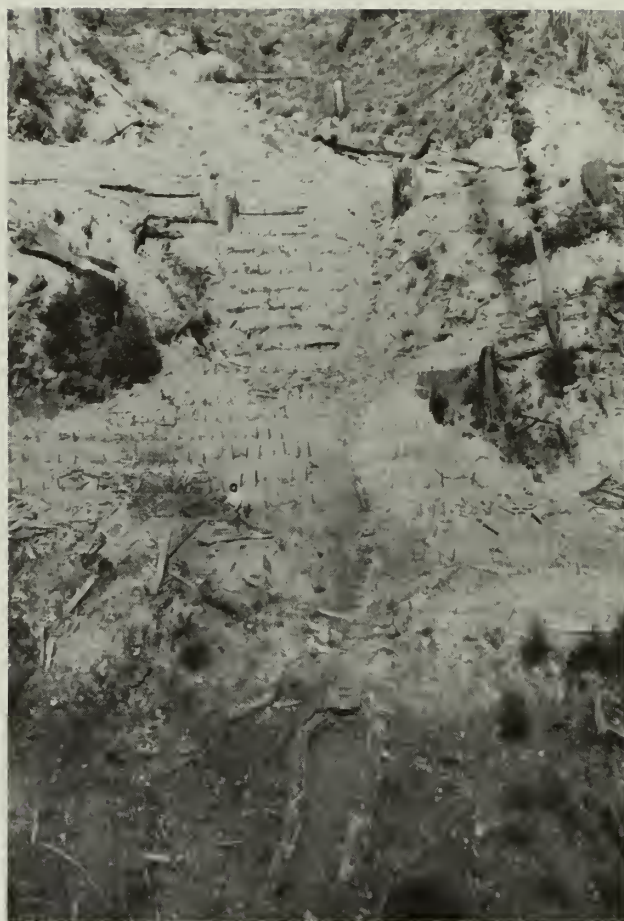
Figure 48: PPA1 1/4/79
After rehabilitation, unstable fill was removed, a small channel was cleared of debris, and slopes were willow wattled. A gully plug was installed at the headcut of a gully (lower center of photo) to prevent the headcut from migrating upstream. Details of the structure are given in Chapter IV.

By September, 1978, a long gully had developed on the Bond Creek Unit (Figure 48), and a six foot knickpoint in the gully was beginning to migrate upslope. A gully plug installed at the knickpoint protected the headcut from further migration and erosion while conveying water across the sensitive area (Figure 75). In this respect the gully plug was used as an alternative to a water ladder in treating this erosional problem.

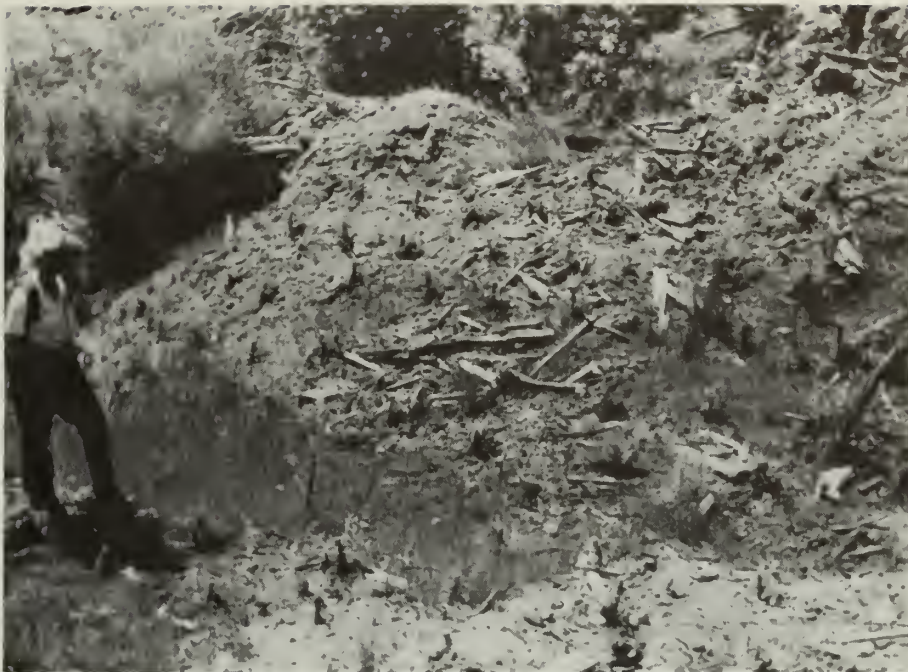
Figure 49: June, 1979
Bare ground on Upper Bond Creek's recently disturbed slopes were sprig planted with willows in December, 1978 at a three foot spacing. The stem cuttings are beginning to sprout.

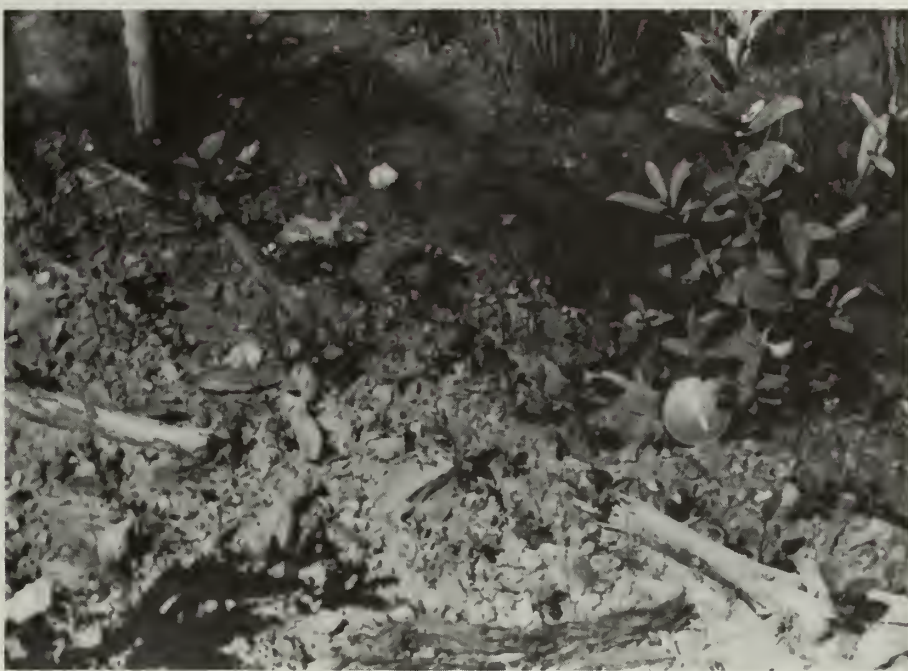
Figure 50: June, 1979
Close-up shot of a willow stem cutting that is sprouting vigorously. This site is damp year round.

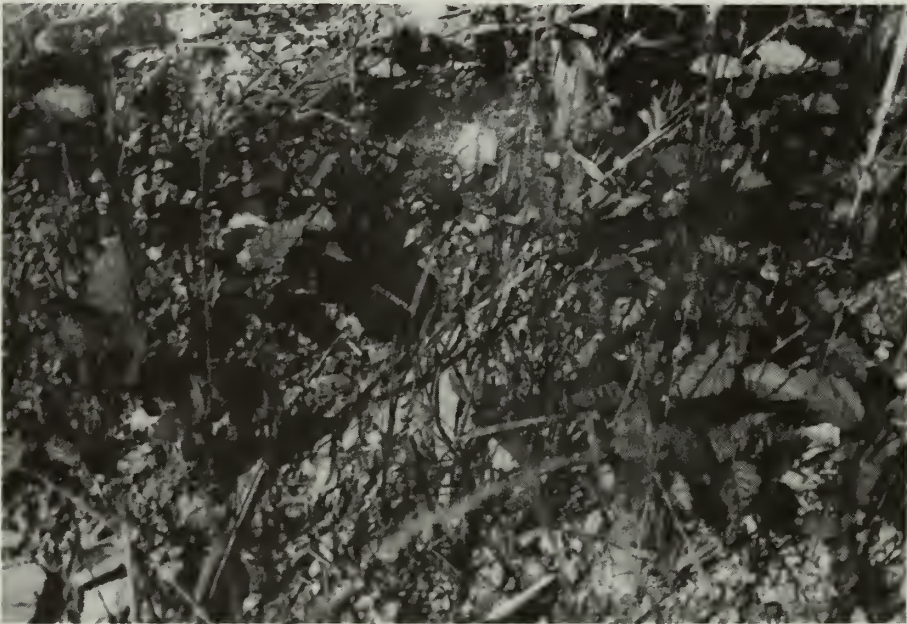
Figure 52: June, 1979. Young alder seedlings. Alder seed was broadcast seeded in January, 1979, on excavated stream channel banks on the Bond Creek Unit.

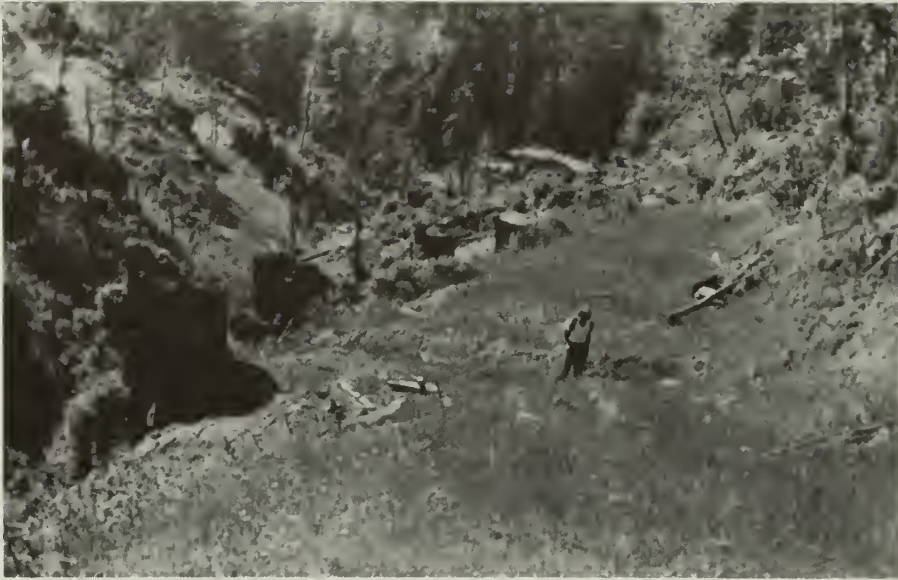
Figure 54: June, 1979
Skid road in Bond Creek Unit with thick stand of annual and perennial ryes and other grasses. The site was broadcast seeded in December, 1978. No rilling is present. Ground cover is about 70% of which 75% is perennial rye.

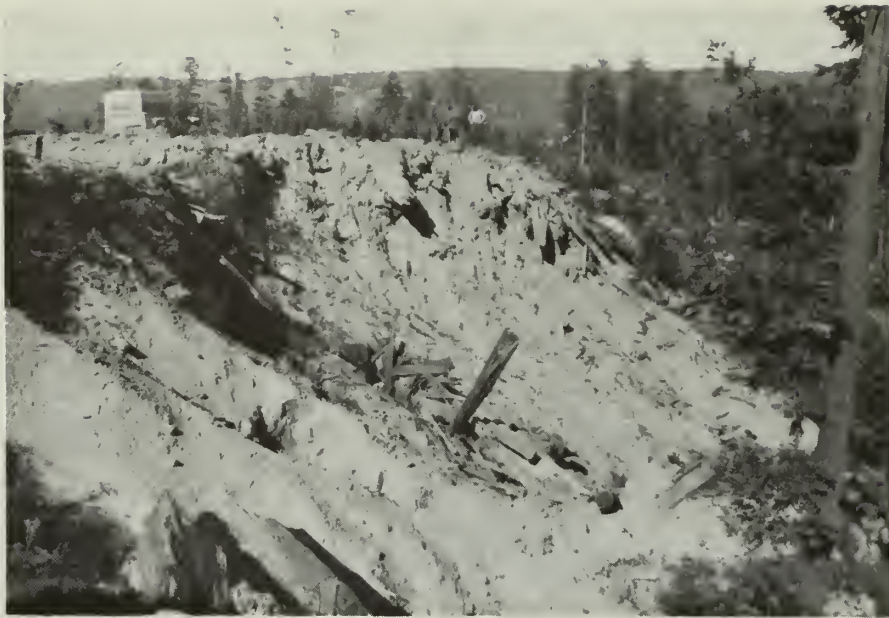
The crane and tractor were unable to remove all large organic debris at the toe of the landing. This debris is well keyed in, and buttresses the rest of the slope. At present it is stable; however, in time natural decomposition of the organics may lead to failure of some of the overlying material. Except for some minor settling in disturbed fill material, there are no indications at present of instability on or adjacent to the former landing. Eight photo points were established and will be used to document changes on the former landing in a qualitative manner (Figures 55-59).

Figure 58: PP6 10/2/78
Before and after sequence showing the removal of the C-Line landing. The upper slopes have willow wattles; the steep lower slopes are protected by planter boxes.

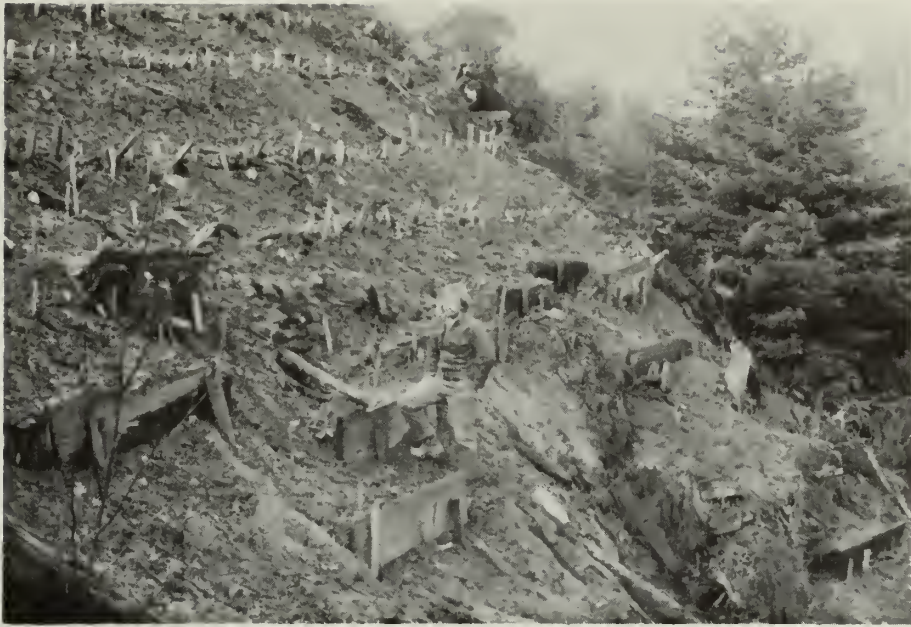
Erosion control structures have worked well on this site. Planter boxes (Figure 60) at the base of the recontoured slope are log and board barriers keyed into steep, infertile soil. They provide a protected, stable planting substrate in harsh areas. All planter boxes remained secure and stable throughout the winter, and they trapped small particles of soil moving downslope.

Figure 60: 12/7/78
At the base of the C-Line landing (Site 78-5), below rows of wattles, planter boxes were secured to the slope. They were backfilled with soil and planted with willow stem cuttings to promote revegetation on an otherwise harsh site.

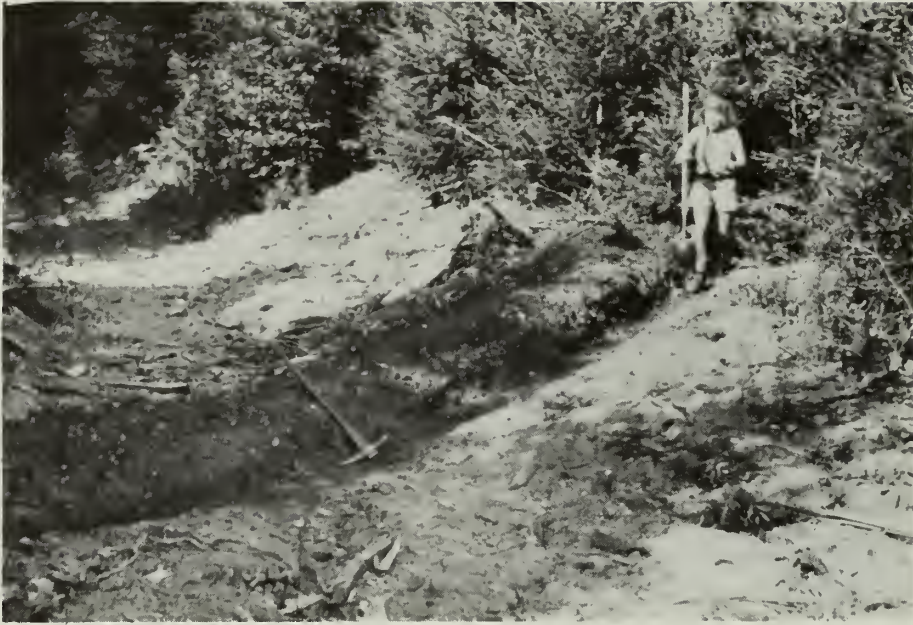
Waterbars on the Bond Creek Site were excavated by backhoe or hand-excavated. Fifteen waterbars were dug by backhoe on a main skid trail, at a cost of approximately \$2 per waterbar. In contrast, 12 waterbars were hand-constructed at a cost of \$30 per bar. An example of a hand-constructed waterbar on the Lower Bond Creek Unit is shown in Figure 61. Both types of waterbars effectively diverted winter runoff flows from skid trails onto vegetated areas.

Figure 61: June, 1979
A hand-constructed waterbar on the Lower
Bond Creek Unit. Runoff from the skid
road is diverted into heavily vegetated
area behind the person in the photo.

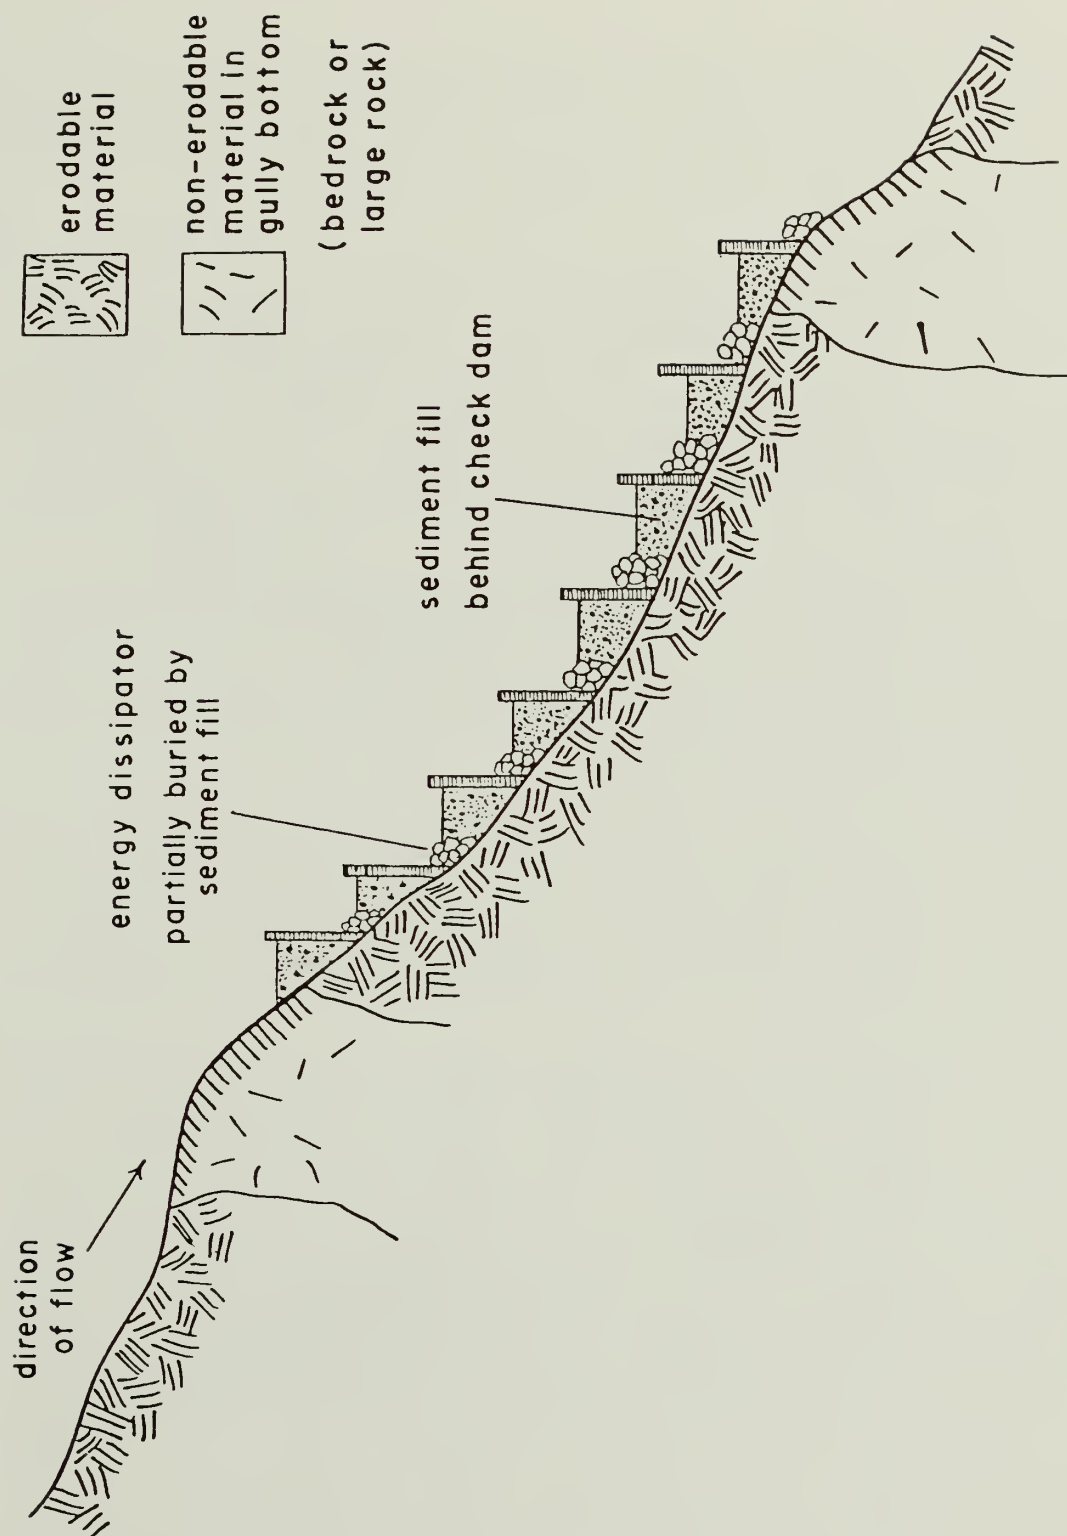
Check dams installed sequentially in a channel prevent failure of individual dams by downcutting at the base of a dam (Figures 62 and 64). The lowest check dam in a gully reach should be constructed on a non-erodible base, and all upstream dams should be placed so that the sediment fill behind the downstream dam abuts the base of the next upstream dam. Therefore, check dams and their trapped sediment totally cover the channel reach, and running water moves over one check dam step, through the energy dissipator device, and onto the next lower level of ponded sediment.

Figure 62: Profile along a gully bottom showing proper placement of a series of check dams with lowermost check dam built on a non-erodible base (called a base level).

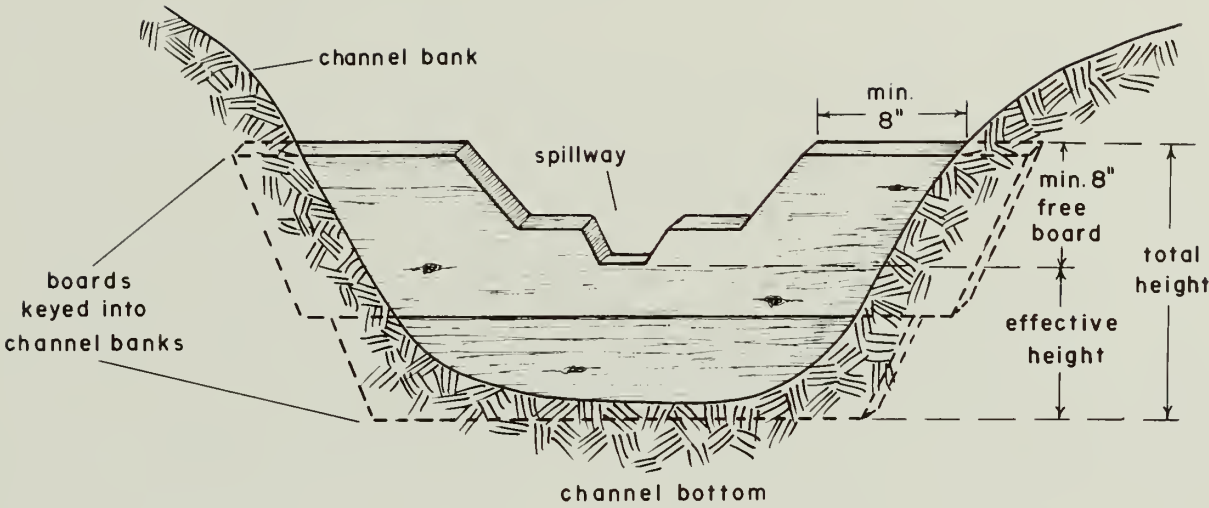
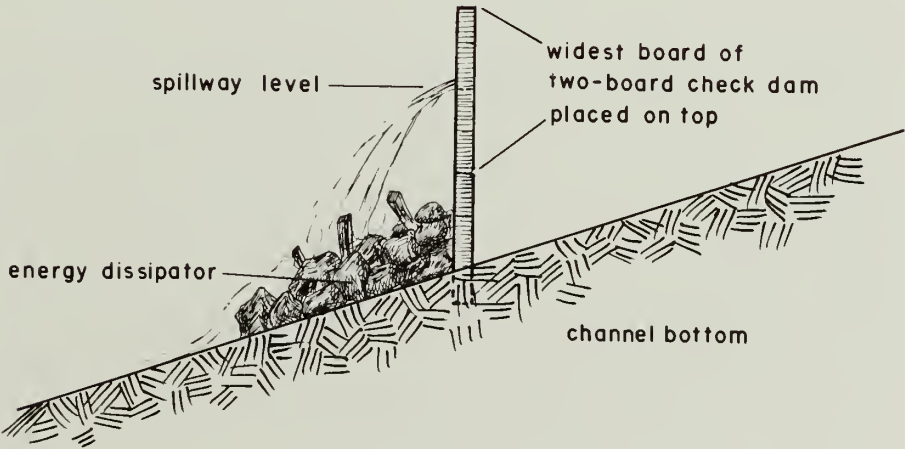
Figure 63: Schematic drawing of split redwood board check dam

All dams at Miller Creek had rock energy dissipators (Figure 63) that generally worked well. In a few cases, as water flowed over the spillway and hit the rocks below, it was diverted sideways to the edges of the backwater basin. Here water potentially could pond or cut laterally around the dam if preventive measures are not taken (for example, wing walls).

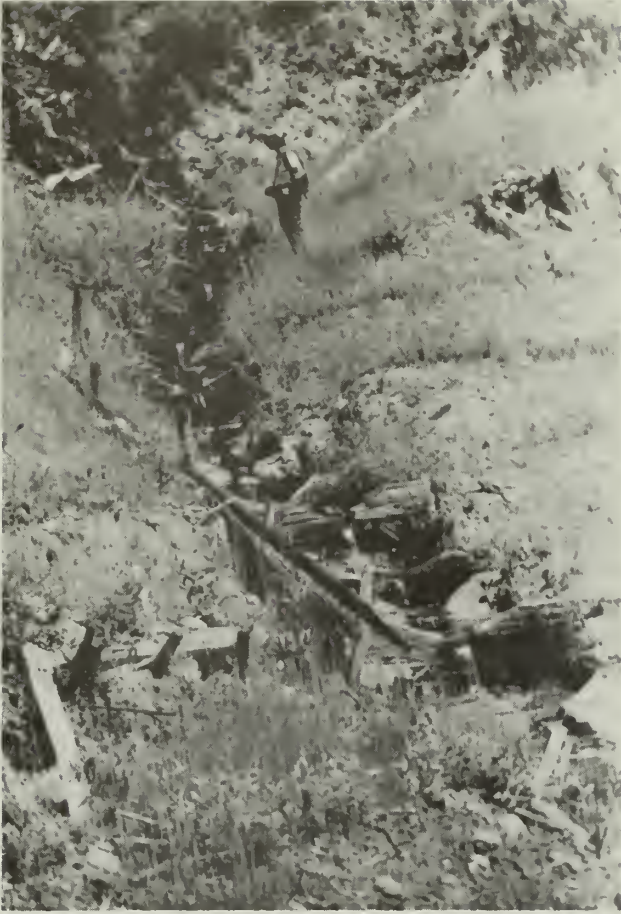
Figure 64: June, 1979

A series of check dams protect a stream channel cleared of road fill and organic debris on the Bond Creek Unit. All dams are well keyed into channel banks and bed. Dams are located so that sediment deposited behind one dam abuts against the base of the next upper check dam. In this manner, the entire disturbed reach of channel is protected from downcutting.

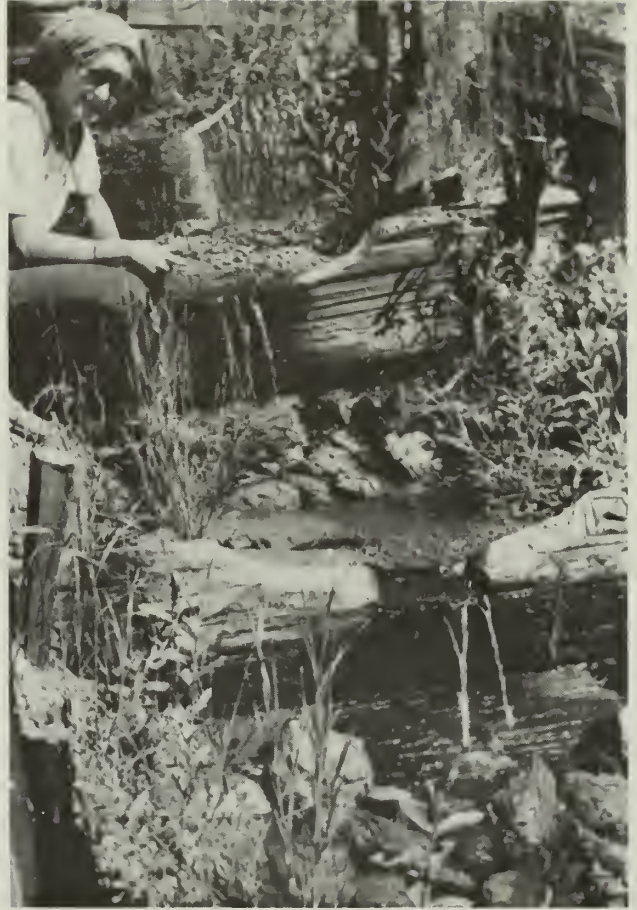
Figure 65:

A close-up view of a series of check dams in the Bond Creek Unit. Summer flow is draining through low-flow spillways. Catch basins upstream of the check dams are filled with sediment deposited during winter high flows. Both rocks and splashboards are used as energy dissipators. Note willow stem cuttings are sprouting and locally, grass is well established.
